**Hydro-geological Site Assessment  
Proposed Student Focused Housing  
409 Huron Street  
Toronto, Ontario**

Ma002568c  
(rev.) May 8, 2019

This report presents the results of a hydro-geological study carried out in the property located at 409 Huron Street in Toronto, Ontario.

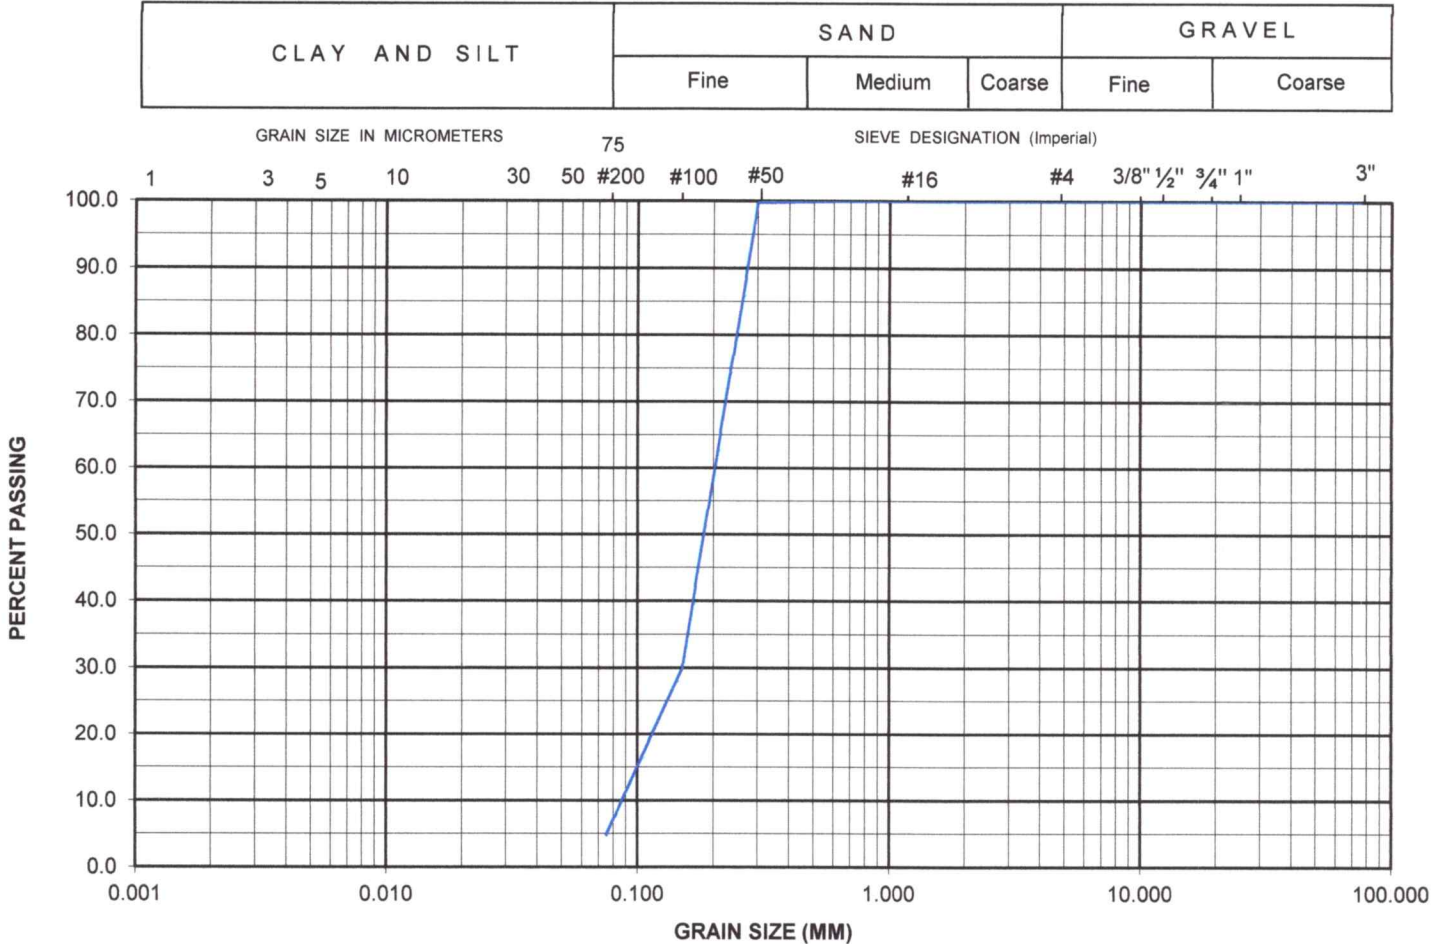
# Grain Size Analysis and Hydrometer Test

Grain Size (mm)	% Passing	Grain Size (mm)	% Passing
75.00	100.0		
26.50	100.0		
19.00	100.0		
13.25	100.0		
9.50	100.0		
4.75	100.0		
2.00	100.0		
1.180	100.0		
0.600	100.0		
0.300	99.8		
0.150	29.8		
0.075	4.8

100% Sand (75µm to 4.75mm), 4.8% Silt (2µm to 75µm), 0% Clay (<2µm)

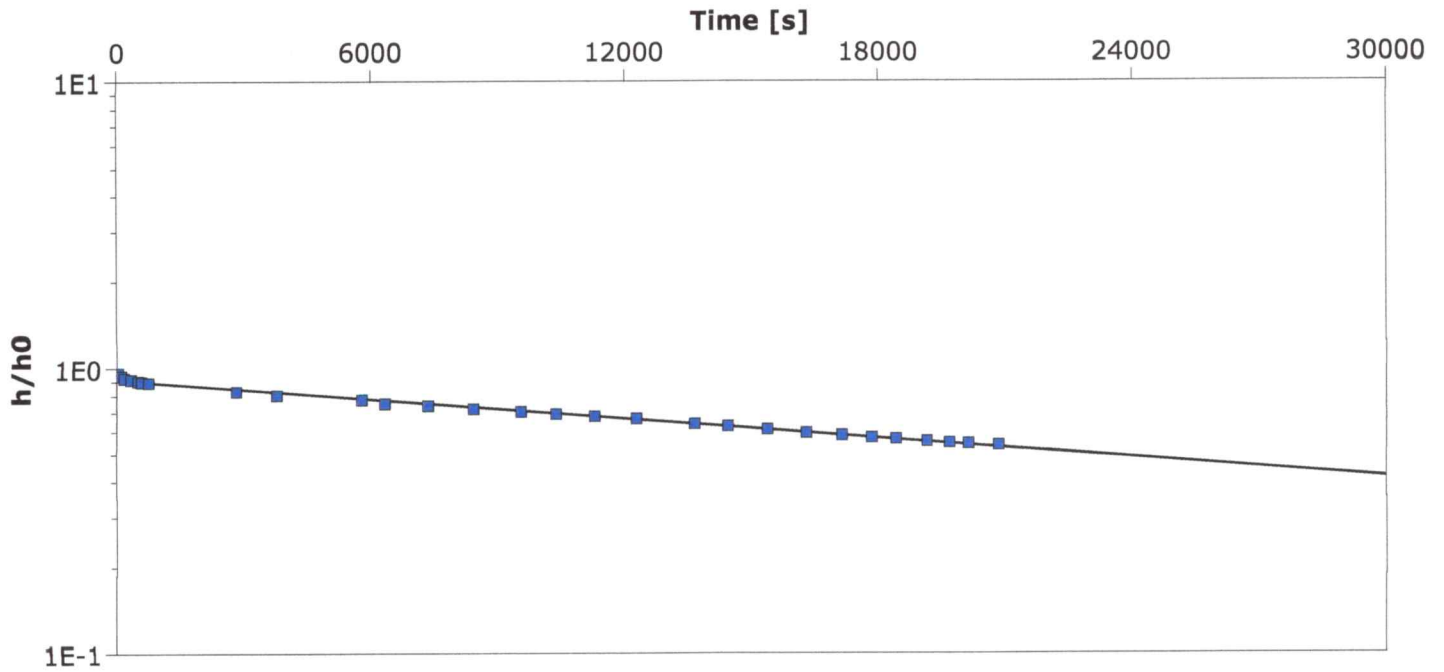
Aquifer Thickness: 7.95 m

Calculation after Hvorslev

Water level readings and results of the slug test are provided in Appendix C of the report. The hydraulic conductivity of the native silt clay was found to be  $6.82 \times 10^{-7}$  m/min ( $1.1 \times 10^{-8}$  m/ sec.). Water level readings and results of slug test analysis are provided in Appendix C.

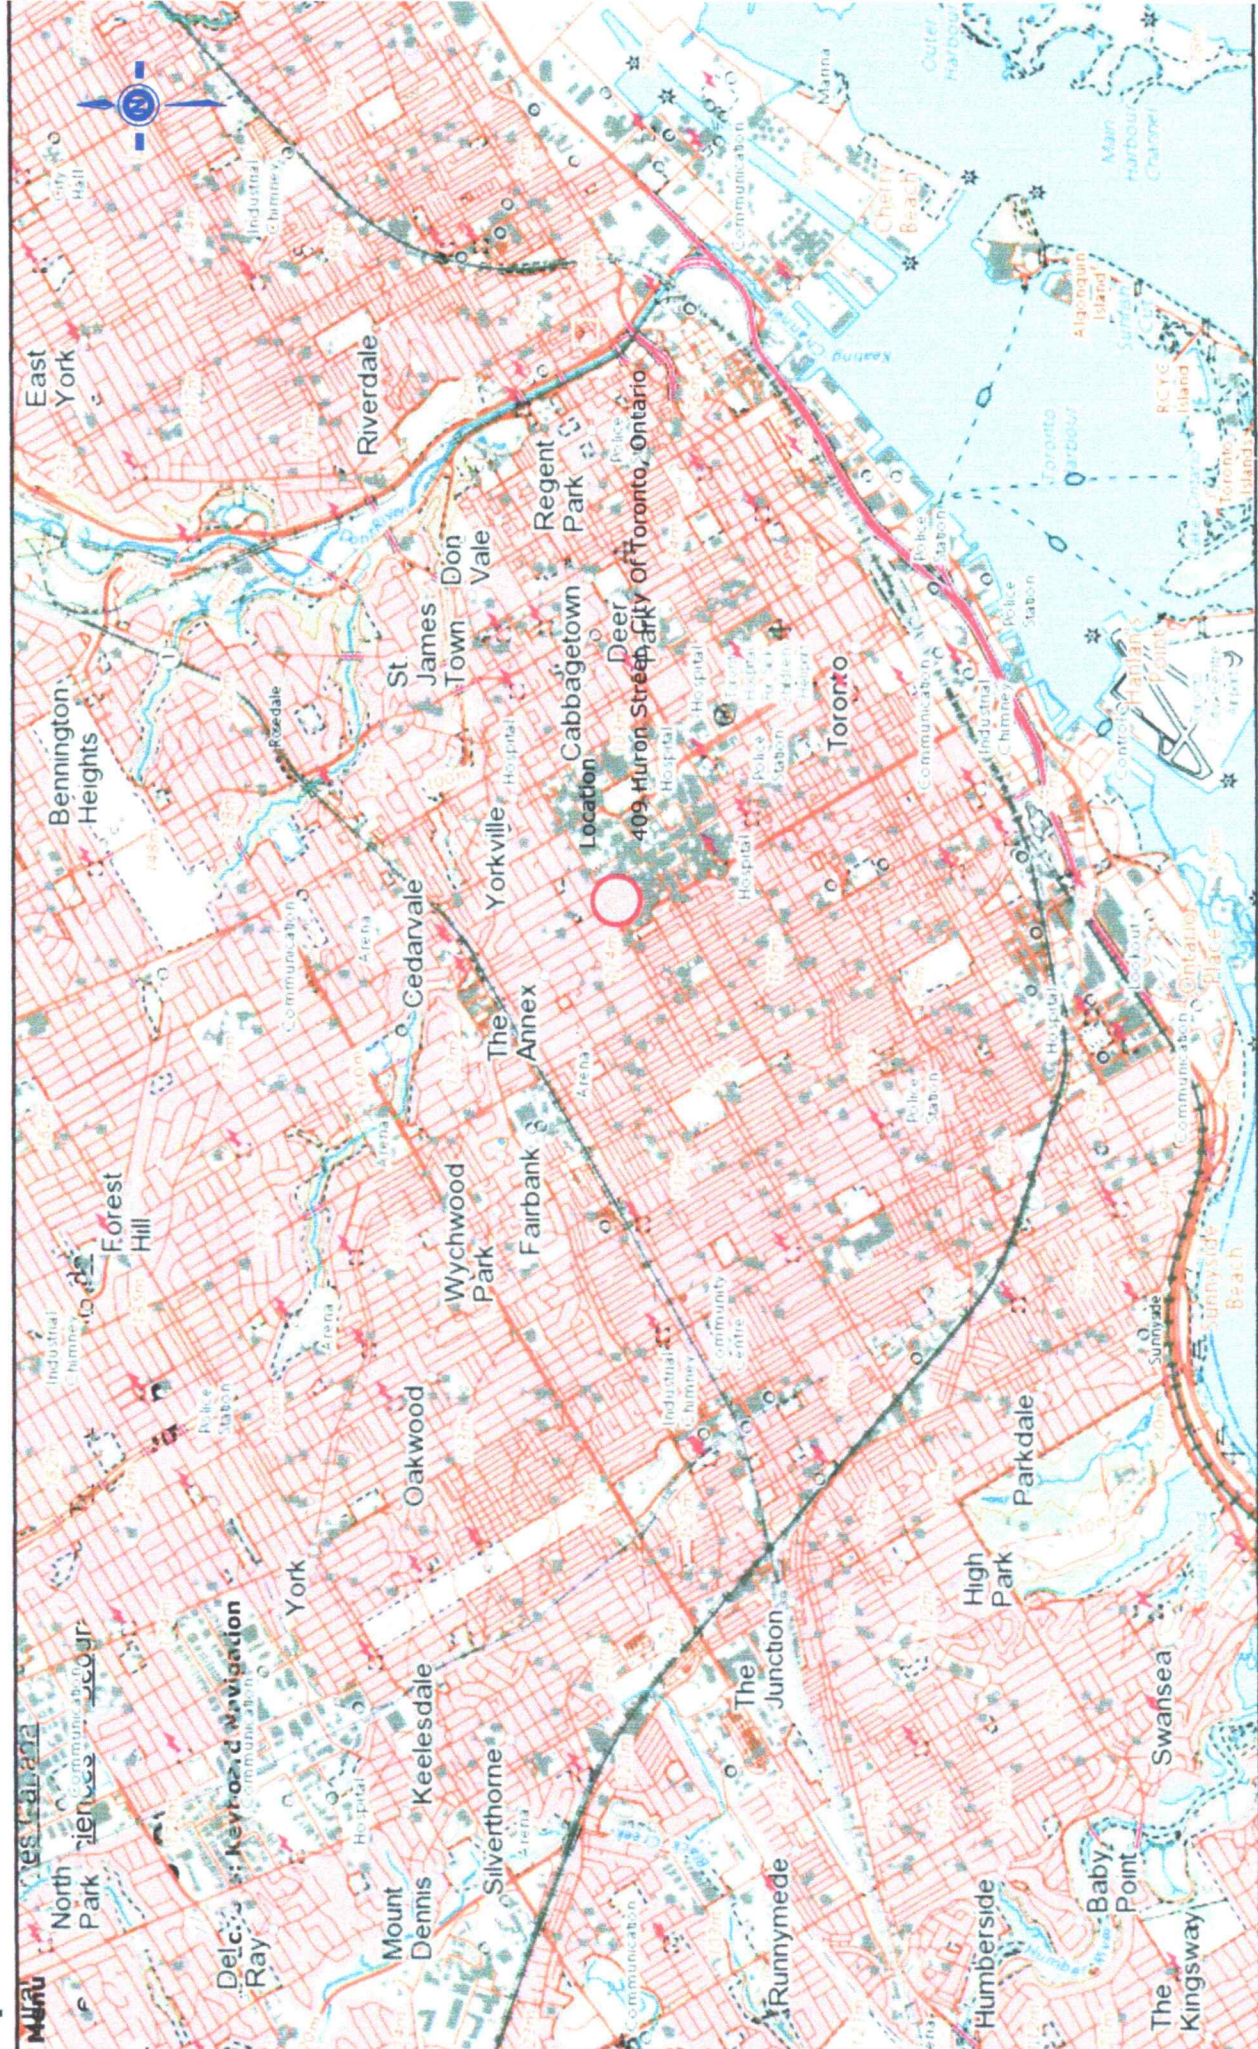
Drawing No. #: 4  
 Date: December 17, 2018  
 Scale: As shown

Title: Topographical Map  
 Project No: Ma002568c  
 Project: Proposed Student Focusing Housing  
 Location: 409 Huron Street, Toronto

Topographical Map..... Drawing No. 4
